Runway incursion detection

Ronaldsway Airport

Manx Government

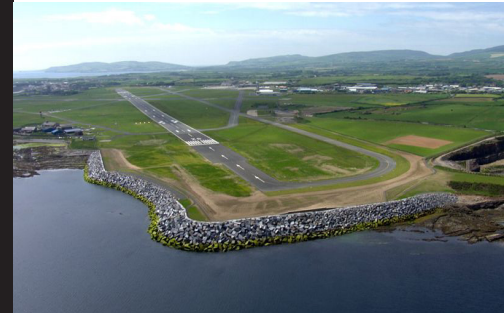
STRIDE is an Atg airports’ runway incursion system that is designed to detect the unauthorised entry onto the runway area when a stopbar is raised. This is achieved through the use of 2 sets of Microwave Detection Barriers (MDB) placed after the stopbar, the first set at the 3m point and the second set at 45m beyond the stopbar. The system will also provide audible and visual alarms in the tower, and can also be used to select ‘Runway Status Lights’ on if installed.

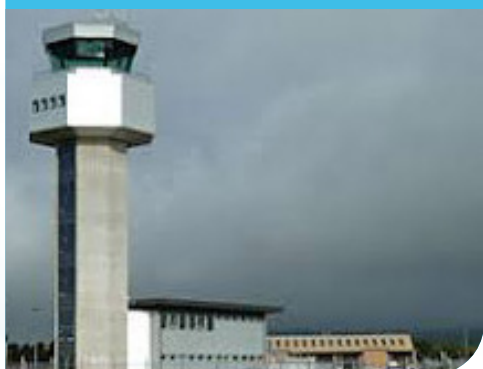
Under normal circumstances the MBD units can also be used to automatically re-select the stopbar and extinguish any lead on lights when an aircraft has moved safely through the monitored area. SMARTCONTROL is operational at the Isle of Man airport, and the STRIDE system has recently been installed on one stopbar in order to monitor its performance before rolling out to others. The functionality of the system, was agreed in a design specification which was written around the operation of the airport’s needs. For each stopbar a different functionality can be configured dependant on the airport’s requirements and lighting arrangements. The configuration at the Isle of Man was to employ two stages of alarm and visual representation on the airfield overview. The new software was uploaded while the engineering team were on site completing the installation of the MDB equipment. A ‘stage 1’ incursion is triggered when a vehicle

crosses the illuminated stopbar at Alpha 1 (A1), a visual indication shows on the airfield mimic. This brings up an alarm banner and also an “A1 RUNWAY INC” label on the mimic. A ‘stage 2’ incursion is triggered when the vehicle or aircraft has crossed the lit A1 stopbar and also breaks the MDB 1 and then breaks MDB 2 beams. This then brings a critical alarm and a runway blocked banner on the mimic “RWY 08/26 BLOCKED” is displayed. Once the airfield controller has addressed the situation for either of the both scenarios, the alarms can be cleared and normal operations resumed. For scheduled maintenance and servicing requirements the incursion system can be taken out of service by engineering team from the terminal located in the engineering wing. Full functional testing of the system for all different scenarios were completed, to ensure that all requirements had been covered and the system was fully functional.
